**Project:** National Paediatric Hospital

**Report Type:** Summary of Noise and Vibration Monitoring Results

**Period of Monitoring:** Sensor data 29<sup>th</sup> January 2018 – 18<sup>th</sup> March 2018

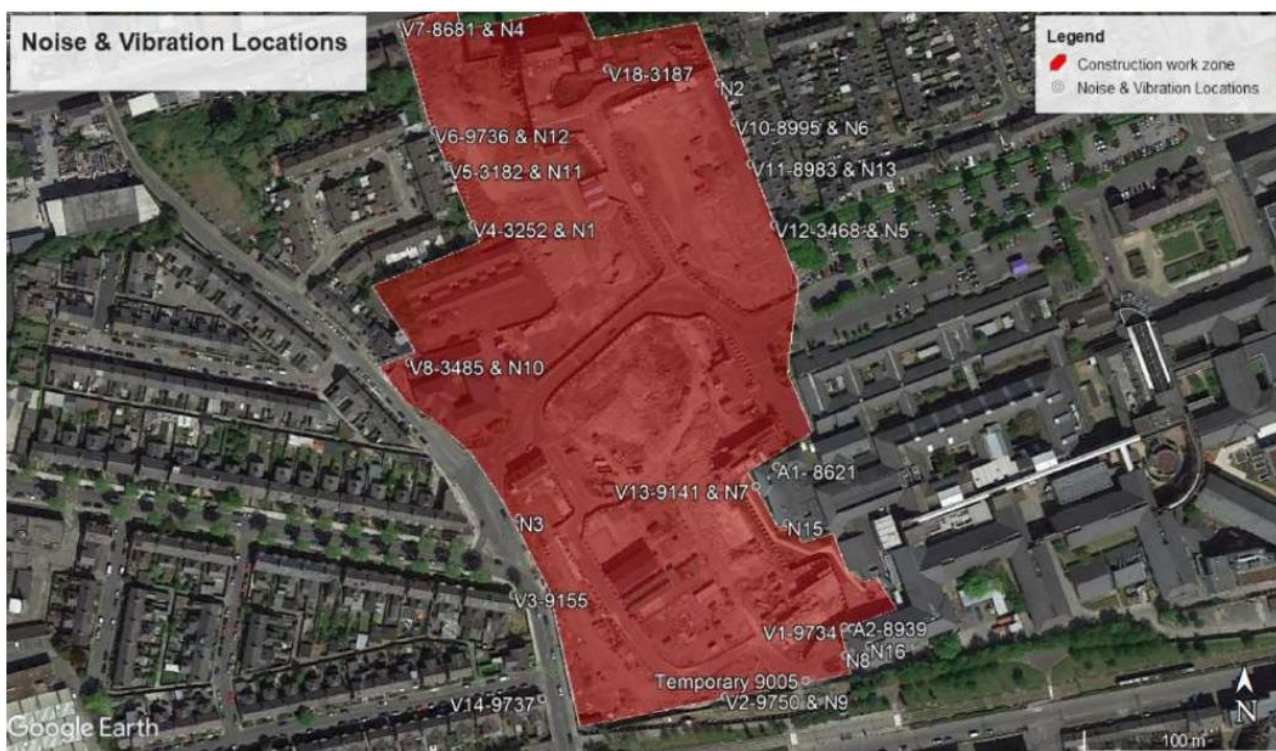
Location of Vibration & Noise Monitors

There are concentrations of monitors at the boundaries with Cameron Square and O’Reilly Avenue where works have been ongoing on site in proximity to neighbouring properties.
