**Project:** National Paediatric Hospital

Report Type: Summary of Noise and Vibration Monitoring Results

Period of Monitoring: Sensor data 7th May 2018 – 4th June 2018

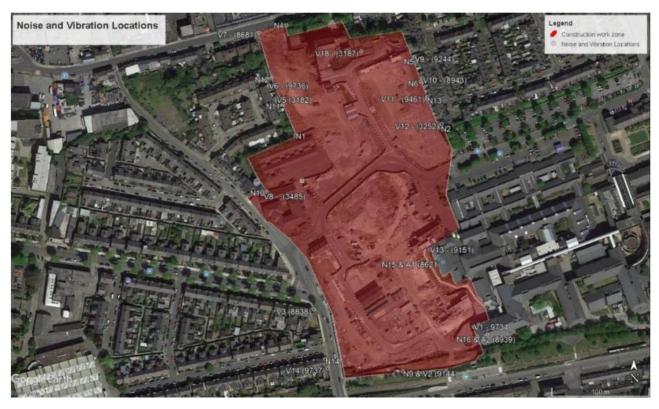
Location of Vibration Monitors

There are concentrations of monitors at the boundaries with Cameron Square and O'Reilly Avenue where works have been ongoing on site in proximity to neighbouring properties.
