Project: National Paediatric Hospital

Report Type: Summary of Noise & Vibration Monitoring Results

Period of Monitoring: Sensor data 30th July 2018 – 3rd September 2018

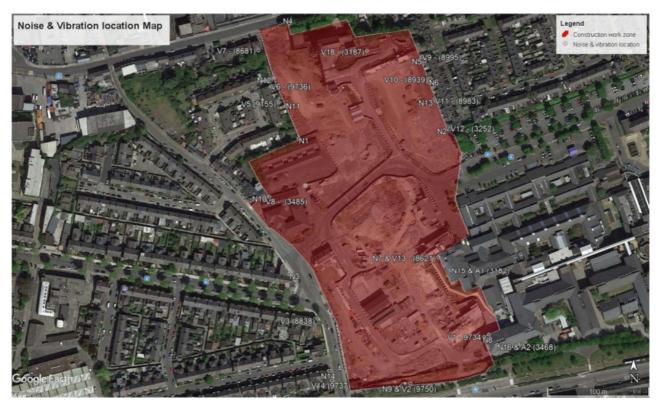
Location of Vibration Monitors

There are concentrations of monitors at the boundaries with Cameron Square and O'Reilly Avenue where works have been ongoing on site in proximity to neighbouring properties.
