Project: National Paediatric Hospital

Report Type: Summary of Noise Vibration & Movement Monitoring Results

Period of Monitoring: 24th June – 11th August

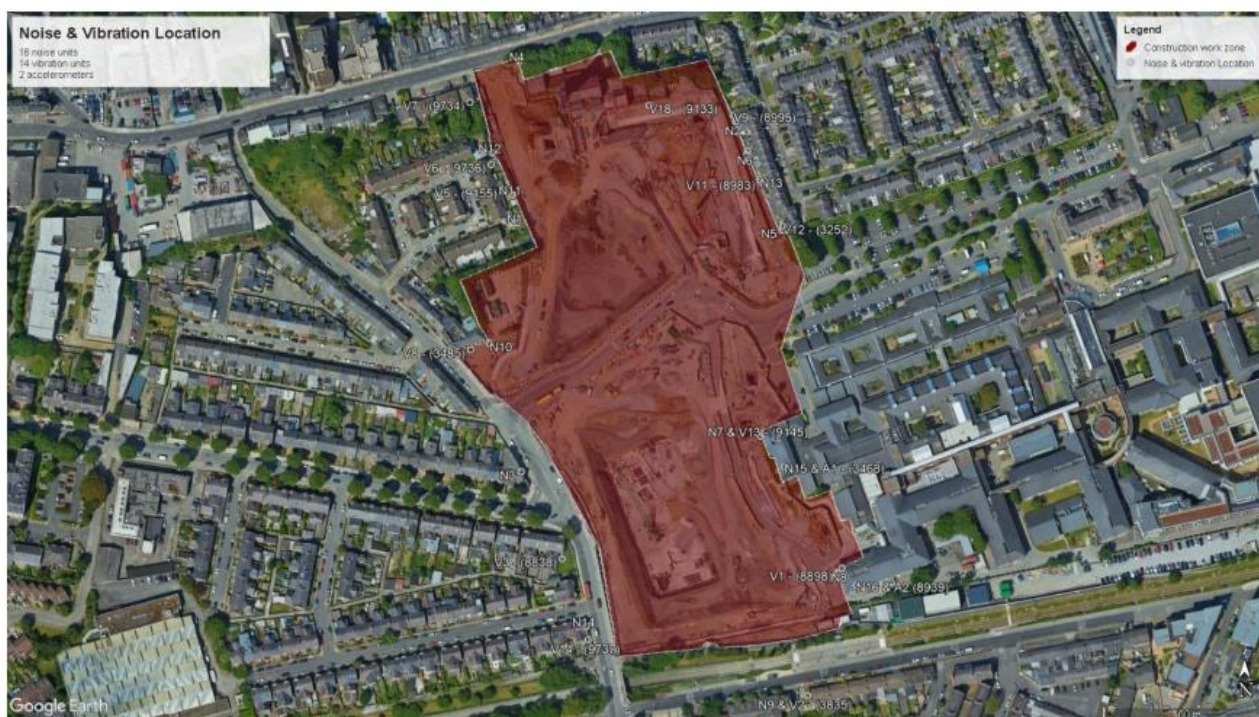
Location of Vibration Monitors

There are concentrations of monitors at the boundaries with Cameron Square and O’Reilly Avenue where works have been ongoing on site in proximity to neighbouring properties.
