**Project:** National Paediatric Hospital

**Report Type:** Summary of Noise Vibration & Movement Monitoring Results

**Period of Monitoring:** 14<sup>th</sup> October 2019 – 18<sup>th</sup> November 2019

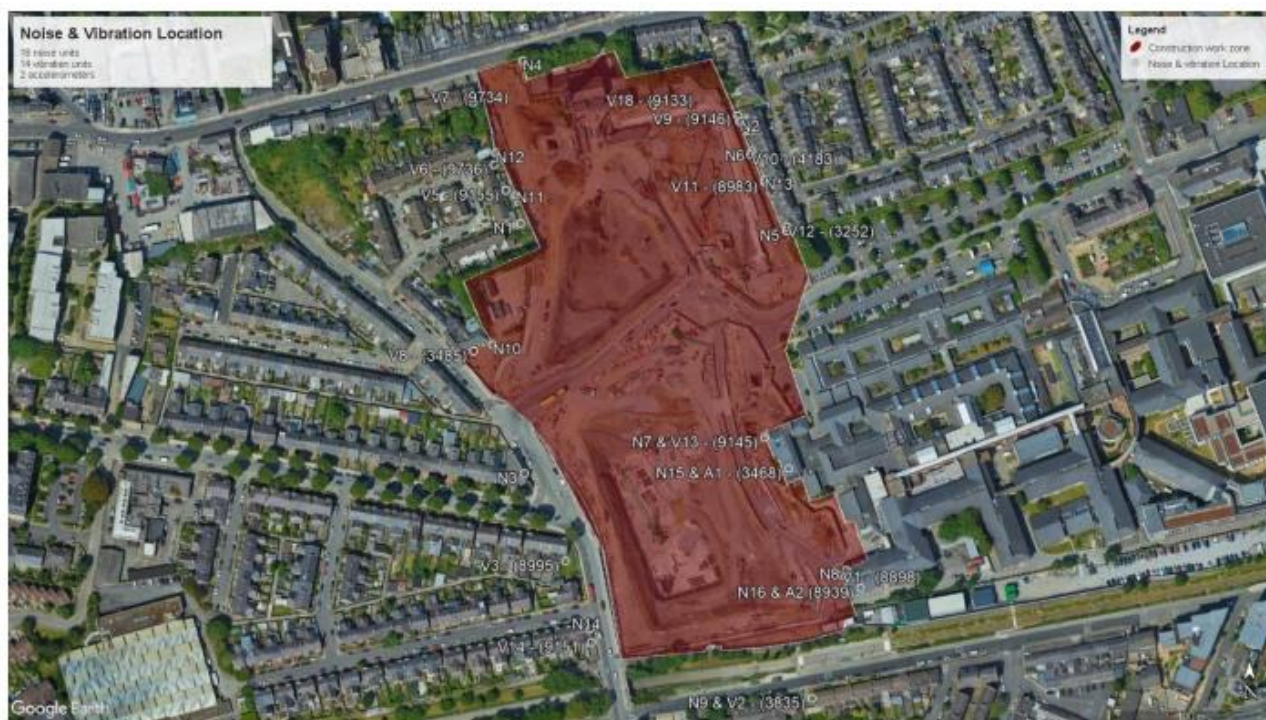
Location of Vibration Monitors

There are concentrations of monitors at the boundaries with Cameron Square and O'Reilly Avenue where works have been ongoing on site in proximity to neighbouring properties.
