Project: National Paediatric Hospital

Report Type: Summary of Noise Vibration & Movement Monitoring Results

Period of Monitoring: 29st March 2021 – 03rd May 2021

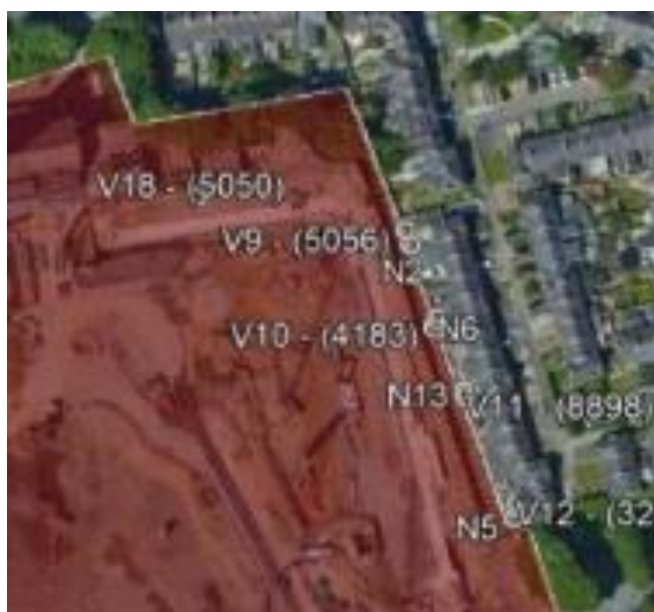
Location of Noise and Vibration Monitors near O'Reilly Avenue

There are concentrations of monitors at the boundaries with Cameron Square and O'Reilly Avenue where works have been ongoing on site in proximity to neighbouring properties.
