Project: National Paediatric Hospital

Report Type: Summary of Noise and Vibration Monitoring Results

Period of Monitoring: Sensor data 11th December – 20th December 2017

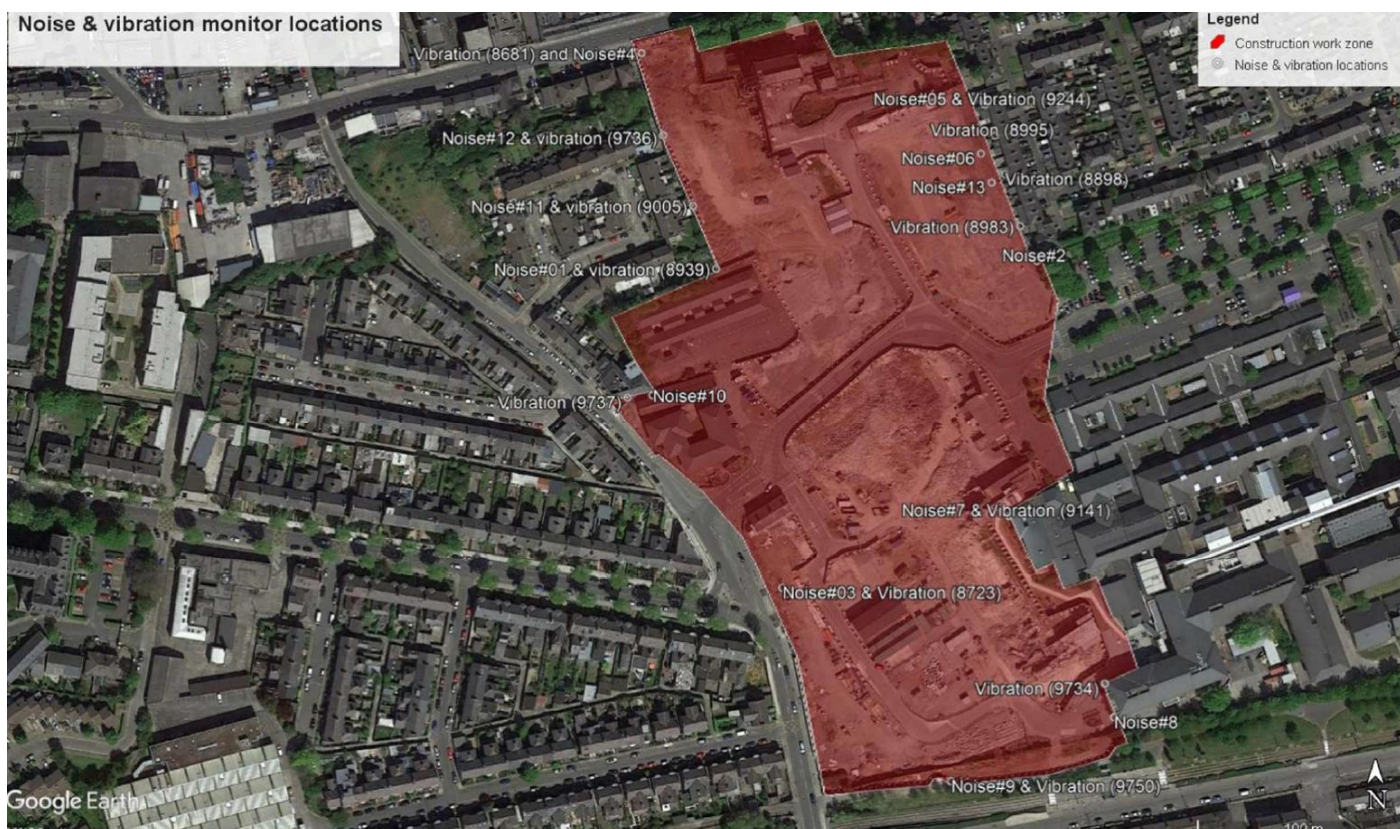
Location of Vibration Monitors

Sensor 9737 has been moved from O’Reilly Avenue to Mount Shannon Road. Sensor 9151 has been replaced by sensor 9000 but it is still on the South Circular Road. Sensor 9005 has been replaced with sensor 9028 but it is still in Cameron Square.

There were 12 active vibration monitors on site in November 2017. One additional monitor was added for December to the rear of O’Reilly Avenue.
