Project: National Paediatric Hospital

Report Type: Summary of Noise and Vibration Monitoring Results

Period of Monitoring: Sensor data 6th November – 4th December 2017

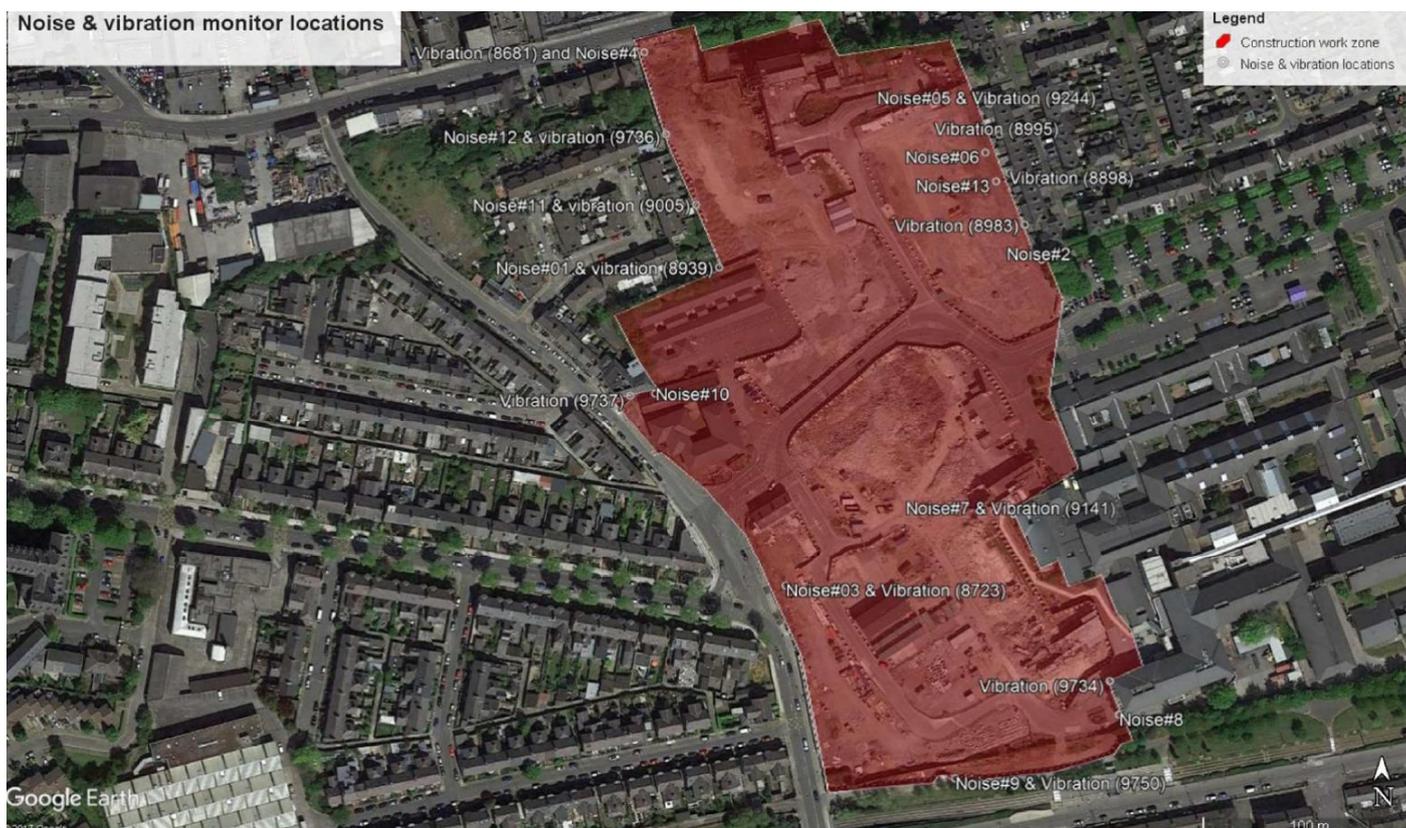
Location of Vibration and Noise Monitors:

Location of Vibration Monitors

During the monitoring period summarised for this report (6th November – 4th December 2017) there were up to 12 active vibration monitors installed at the perimeter of the site.

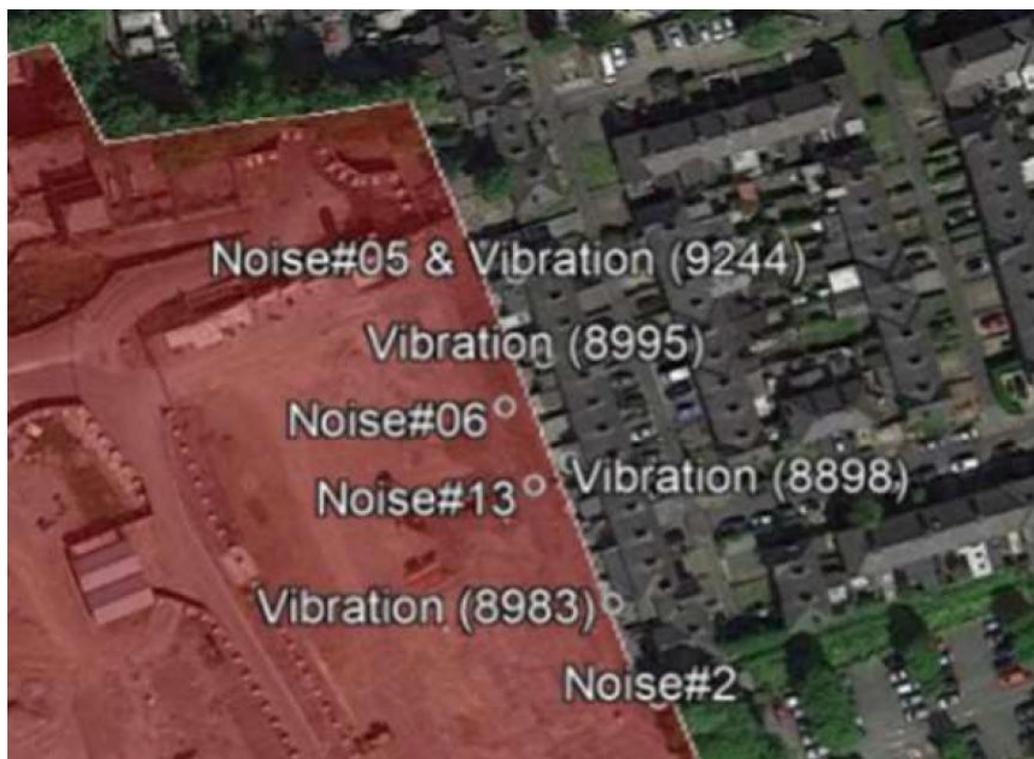
Location of Vibration Monitors around O'Reilly Avenue
