Project: National Paediatric Hospital

Report Type: Summary of Noise Vibration & Movement Monitoring Results

Period of Monitoring: Sensor data 3rd September 2018 – 1st October 2018

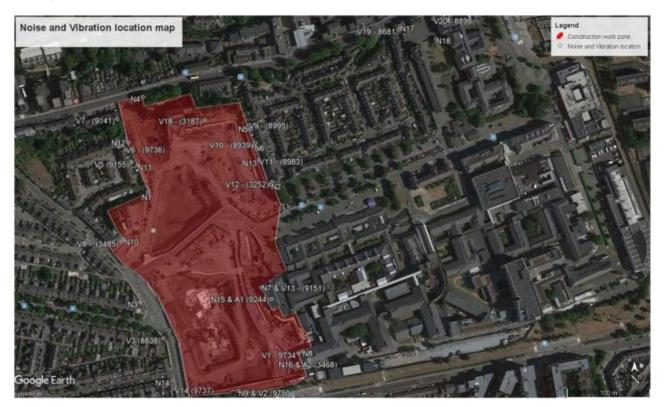
Location of Vibration Monitors

The layout of the monitors is as seen below:

There are concentrations of monitors at the boundaries with Cameron Square and O'Reilly Avenue where works have been ongoing on site in proximity to neighbouring properties.

Vibration monitors have been located at the 'closest part of sensitive property' as per the Project Environmental Impact Statement where feasible or alternatively at the site hoarding. The monitors will be located as per the above adjacent to locations where significant works are ongoing on site.
