### **Project:** National Paediatric Hospital

# **Report Type:** Summary of Noise Vibration & Movement Monitoring Results

### Period of Monitoring: 26<sup>th</sup> of November – 31<sup>st</sup> of December

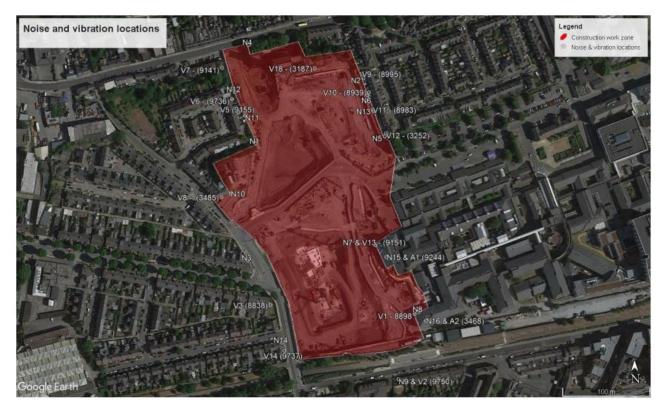
Location of Vibration Monitors

The layout of the monitors is as seen below:

There are concentrations of monitors at the boundaries with Cameron Square and O'Reilly Avenue where works have been ongoing on site in proximity to neighbouring properties.
