Project: National Paediatric Hospital

Report Type: Summary of Noise Vibration & Movement Monitoring Results

Period of Monitoring: 2nd September – 14th October 2019

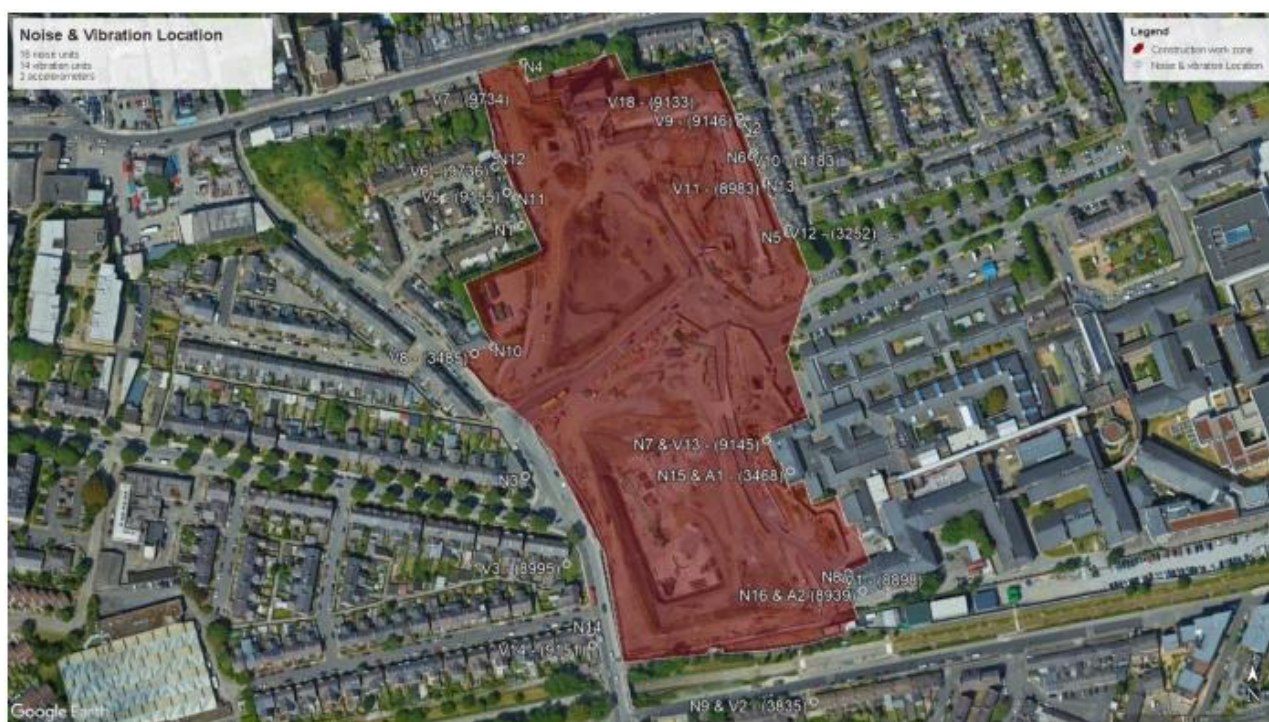
Location of Vibration Monitors

The layout of the monitors is as seen below:

There are concentrations of monitors at the boundaries with Cameron Square and O'Reilly Avenue where works have been ongoing on site in proximity to neighbouring properties.

Vibration monitors have been located at the ‘closest part of sensitive property’ as per the Project Environmental Impact Statement where feasible or alternatively at the site hoarding. The monitors will be located as per the above adjacent to locations where significant works are ongoing on site.
