Project: National Paediatric Hospital

Report Type: Summary of Noise Vibration & Movement Monitoring Results

Period of Monitoring: 04rd January – 01st March

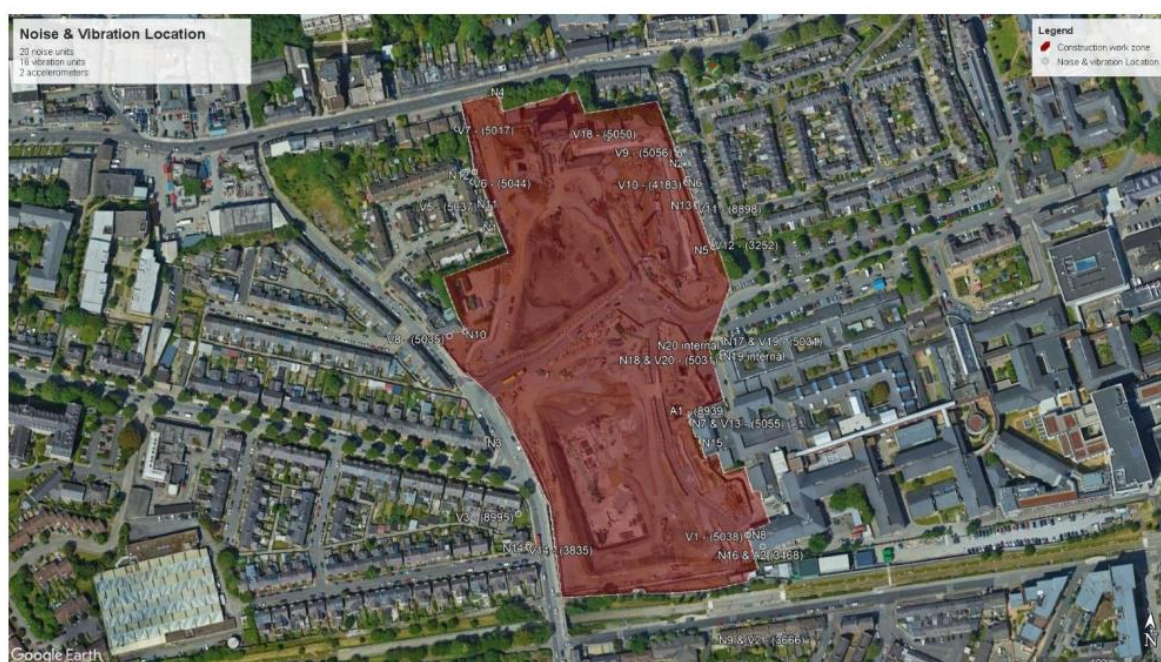
Location of Noise and Vibration Monitors

The layout of the monitors is as seen below:

Vibration monitors have been placed at the 'closest part of the sensitive properties' as per the EIS where this is feasible. Most vibration readings during the monitoring period recorded readings below the limit specified within the Project EIS. Vibration monitors V1, V13, V18, V19, V20 A1 & A2 have been excluded from this report as they are not relevant to the conditions for the residents adjacent to the site. From the remaining 11 monitors:
