**Project:** National Paediatric Hospital

**Report Type:** Summary of Noise Vibration & Movement Monitoring Results

**Period of Monitoring:** 25<sup>th</sup> March 2019 – 21<sup>st</sup> April 2019

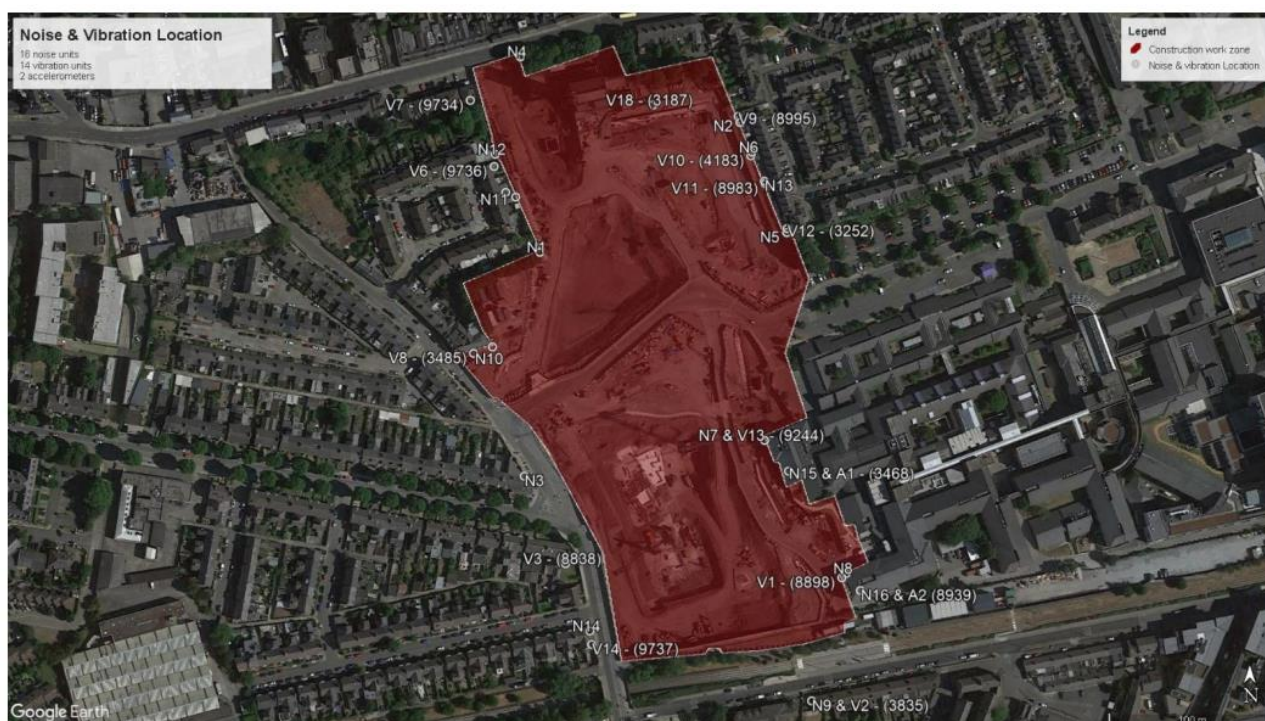
Location of Vibration Monitors

The layout of the monitors is as seen below:

There are concentrations of monitors at the boundaries with Cameron Square and O'Reilly Avenue where works have been ongoing on site in proximity to neighbouring properties.
