**Project:** National Paediatric Hospital

**Report Type:** Summary of Noise Vibration & Movement Monitoring Results

**Period of Monitoring:** 31<sup>st</sup> of December – 11<sup>th</sup> of February

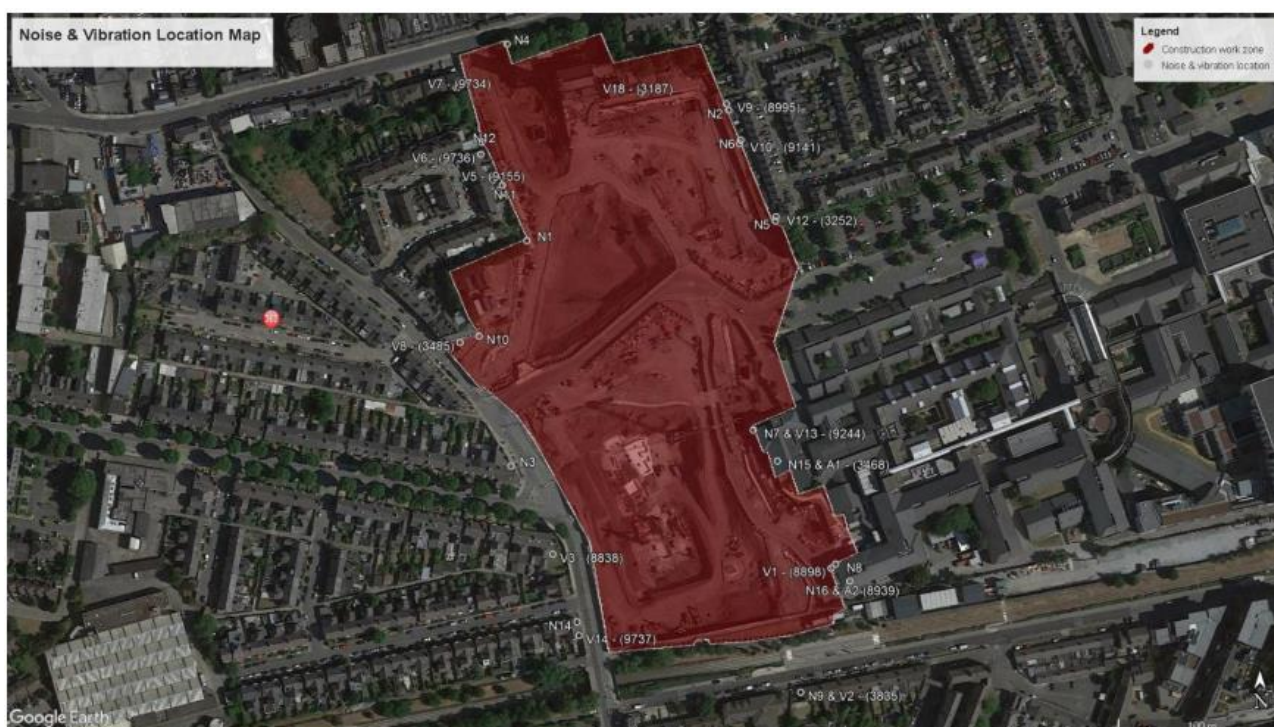
Location of Vibration Monitors

The layout of the monitors is as seen below:

There are concentrations of monitors at the boundaries with Cameron Square and O'Reilly Avenue where works have been ongoing on site in proximity to neighbouring properties.

Vibration monitors have been located at the ‘closest part of sensitive property’ as per the Project Environmental Impact Statement where feasible or alternatively at the site hoarding. The monitors will be located as per the above adjacent to locations where significant works are ongoing on site.
