Project: National Paediatric Hospital

Report Type: Summary of Dust Monitoring Results

Period of Monitoring: December 2017

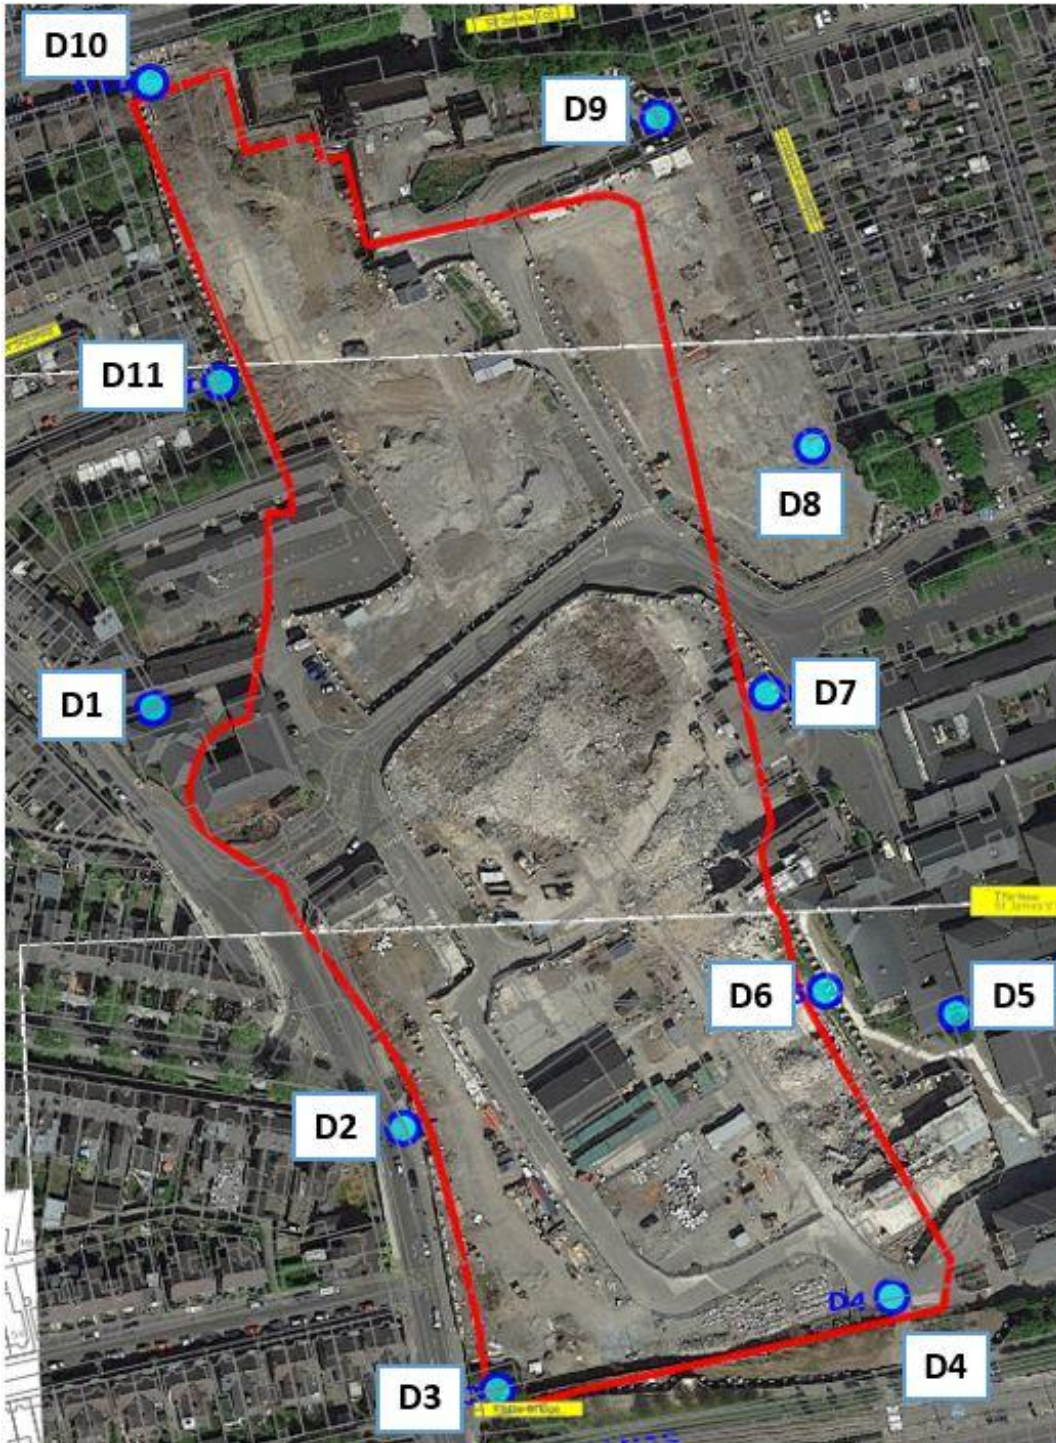
Figure 1. Location of Dust monitors on site (December 2017).

The location of dust monitoring points for November (D1, D2, etc.) can be seen in Figure 1. The dust monitoring location points for December are the same as November. The previous dust monitor locations for the period April to September 2017 are shown in Figure 2 for reference.

Dust Monitoring Point D3 recorded the highest reading and is located near the carpark for St. James's Hospital A&E car park. The dust deposition rate was approximately 3400% of the deposition rate limit specified in the Project EIS.

The report notes that "the results obtained at the dust monitoring location D3 indicate that *the excessive dust (i.e. 12,000mg/m²/day) was likely generated by the operation of a secant piling rig which was in the vicinity of D3 during the sampling period*".

There is a local spill zone from the pile machine which has likely lead to this abnormally high reading. During the monitoring period, works have been ongoing across large areas of site and all other monitors have recorded very low levels of dust deposition (i.e. < 40mg/m²/day) which would indicate that the reading at D3 has been influenced by very localised works.

The monitors are examined monthly and the levels of dust recorded are compared to a dust limit of 350mg/m²/day set out in the Project EIS. The monitoring points are monitored on a 'trigger level' basis - so if a predetermined level of dust is exceeded the Main Contractor shall review work processes and modify as required to reduce the level of dust generated.

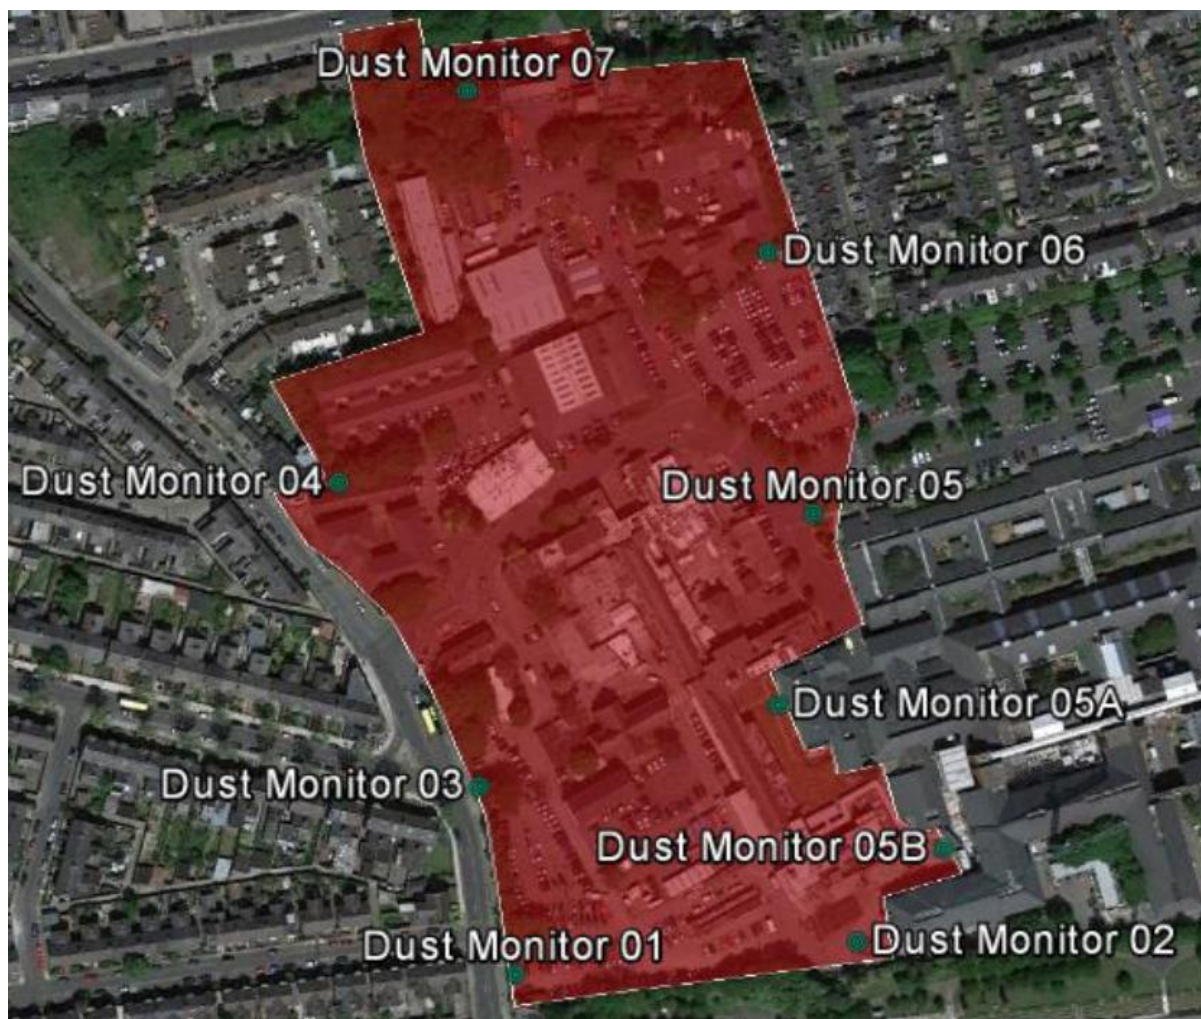
Figure 2. Previous location of Dust monitors on site (April 2017 to August 2017).

Dust Monitoring Point D3 (shown in Figure 1) was previously identified as Dust Monitoring point D1 (shown in Figure 2). All previous results at this point were below the limit identified within the Project EIS.
