Project: National Paediatric Hospital

Report Type: Summary of Dust Monitoring Results

Period of Monitoring: 07th April – 04th May 2021

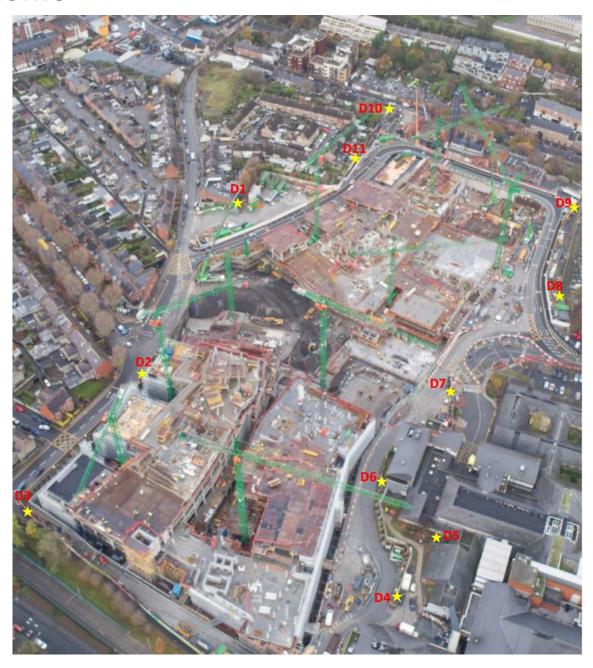
11 no. dust monitors were located around the perimeter of the site. The purpose of which was to identify which, if any work activities might be causing a dust disturbance to the site's adjacent residents. The location of dust monitoring points can be seen in Figure 1.

Figure 1. Location of Dust monitors on site.
