Project: National Paediatric Hospital

Report Type: Summary of Dust Monitoring Results

Period of Monitoring: 04th May 2021 – 2nd June 2021

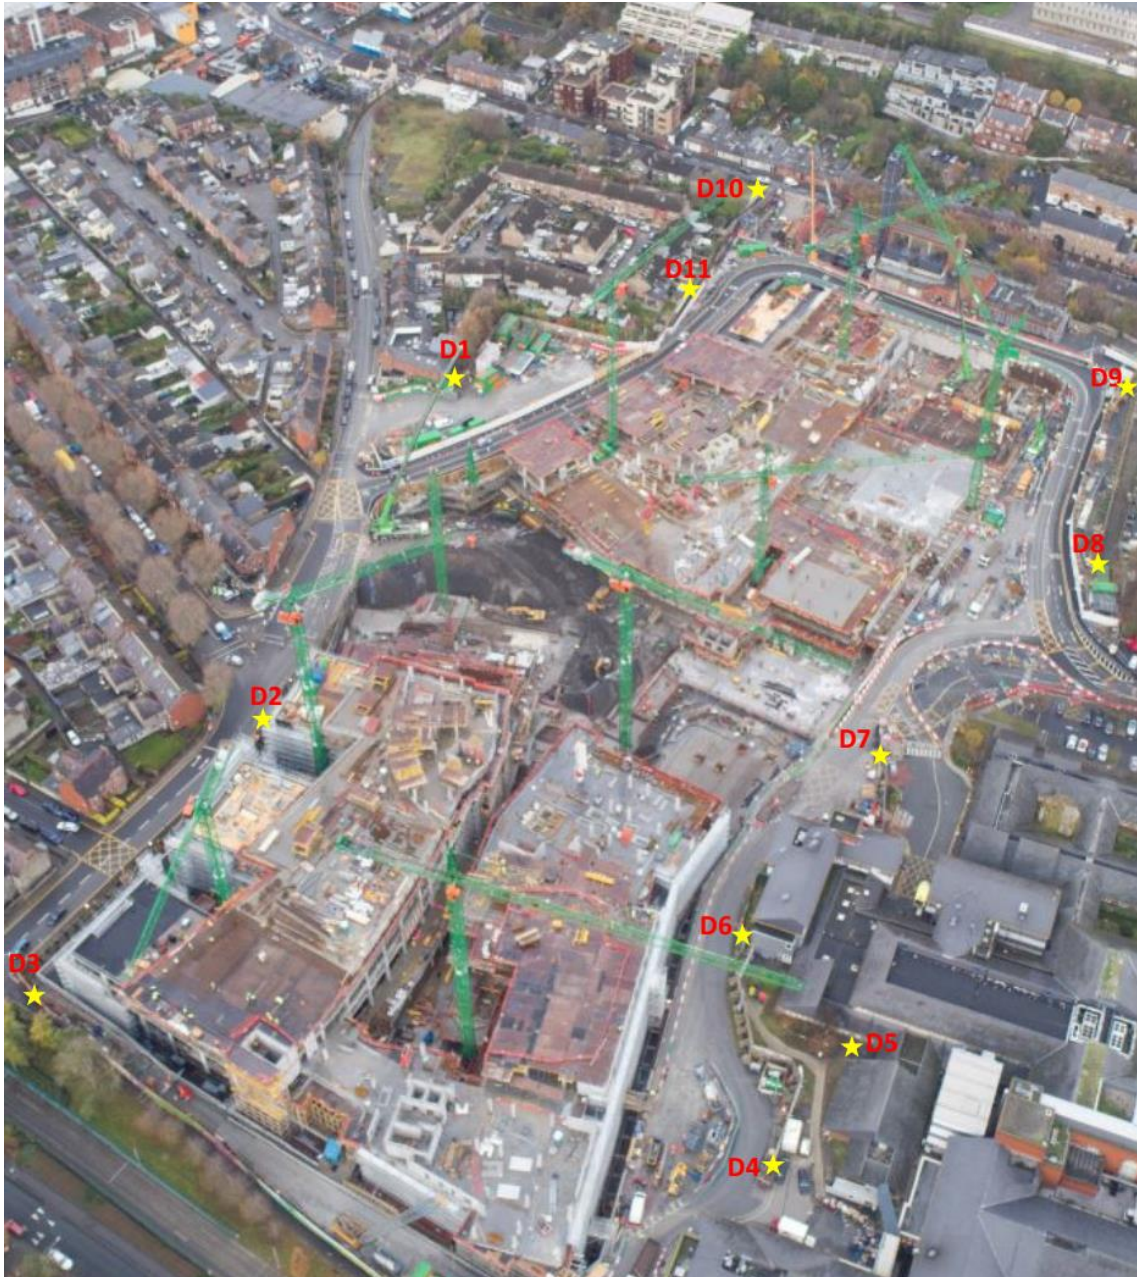
11 no. dust monitors were located around the perimeter of the site. The purpose of which was to identify which, if any work activities might be causing a dust disturbance to the site's adjacent residents. The location of dust monitoring points can be seen in Figure 1.

Figure 1. Location of Dust monitors on site.
