Project: National Paediatric Hospital

Report Type: Summary of Dust Monitoring Results

Period of Monitoring: 6th March 2019 – 8th April 2019.

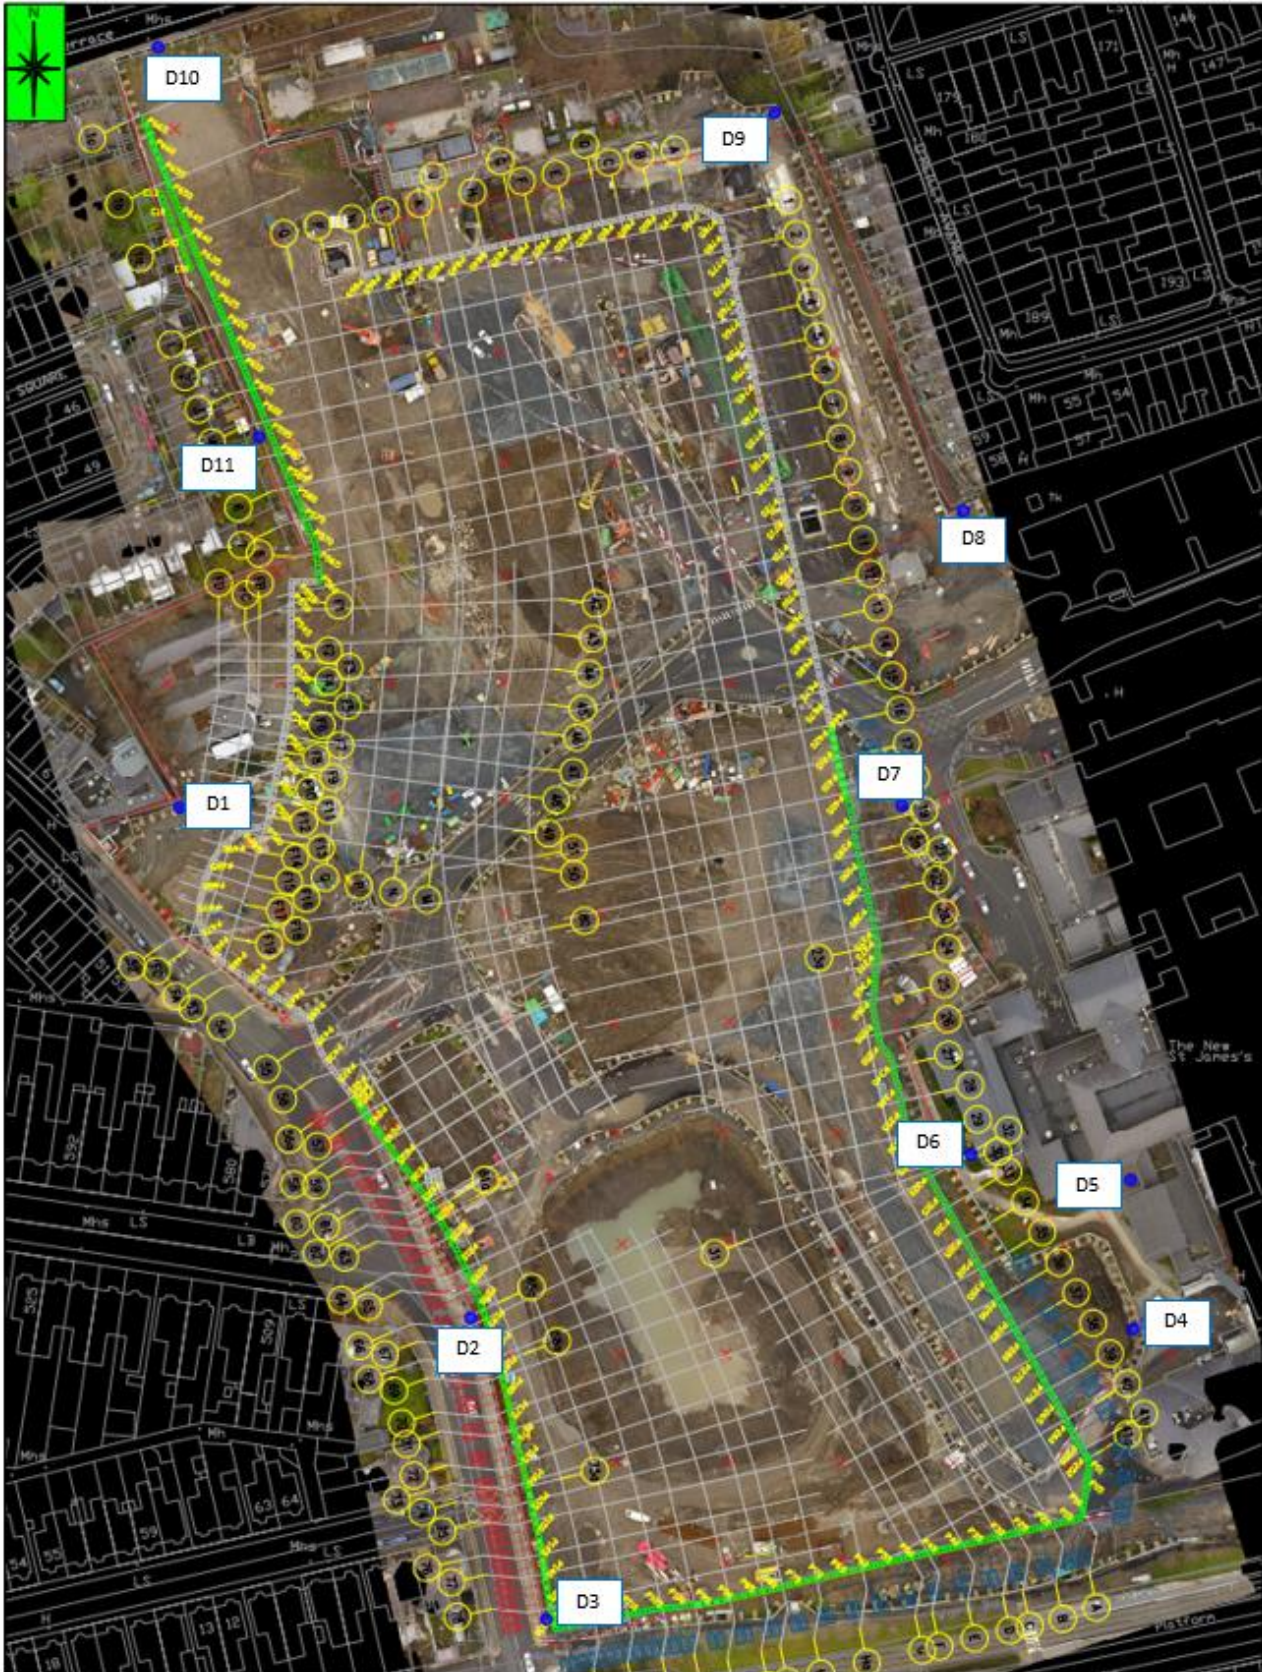
Figure 1. Location of Dust monitors on site (May 2018).

The location of dust monitoring points since May 2018 (D1, D2, etc.) can be seen in Figure 1. Previous dust monitor locations for the period September 2017 to April 2018 and April 2017 to August 2017 and are shown in Figures 2 and 3 respectively for reference.

Dust Monitoring Point D7 was the only monitor to record levels of dust above the levels specified in the Project EIS, 350mg/m²/day. The dust deposition was approximately 62% above the limit. Dust monitor D7 is located in front of the hospital building which was the site of excavation works and concrete pouring which could have added to the higher dust reading. Historically there have been few exceedances in this area, the only other exceedance in this location was in November 2017 (max reading in between these exceedances was 10% of the allowable limit set out in the Project EIS).

The adjacent monitors, D6 & D8, had a dust deposition over this timeframe of <5% of the allowable limit set out in the Project EIS which suggests that the dust deposition was localised around monitor D7.

The monitors are examined monthly and the levels of dust recorded are compared to a dust limit of 350mg/m²/day set out in the Project EIS. The monitoring points are monitored on a 'trigger level' basis - so if a predetermined level of dust is exceeded the Main Contractor shall review work processes and modify as required to reduce the level of dust generated.
